Product Name: **BOV Kompact Kia Stinger**
 Product Description: BOV Kompact Kia Stinger
 Product Number: TS-0203-1025
 Document Version: V1.00 Rev A

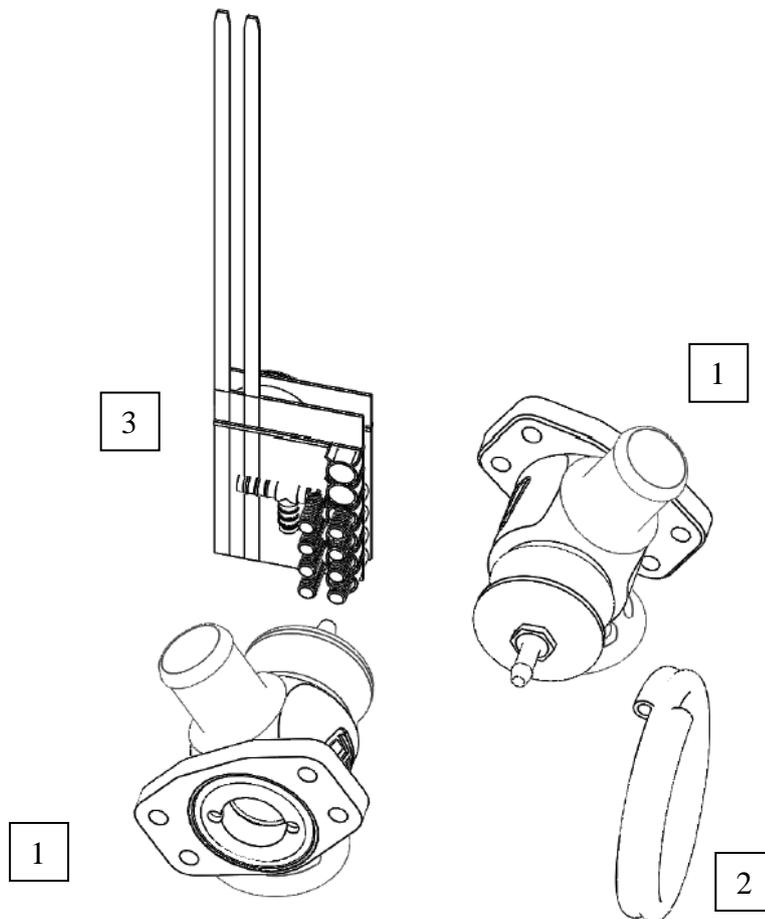
Figure 1 - Kit Contents

Part	Description	Use
1	Turbosmart Kompact Series BOV	Main unit x2
2	Vacuum Hose	Fix plumb back hose to BOV
3.1	M6 Flange Bolts	Mount BOV to mounting flange x8
3.2	Blanking plug	Black off VTA trumpet to convert to pure plumb back. X2
3.3	Cable Tie	250mm cable tie x2
3.4	Tee	Hose Tee piece
3.5	Hose clamp	Spring action hose clamps x6
4	Turbosmart Sticker	Turbosmart sticker

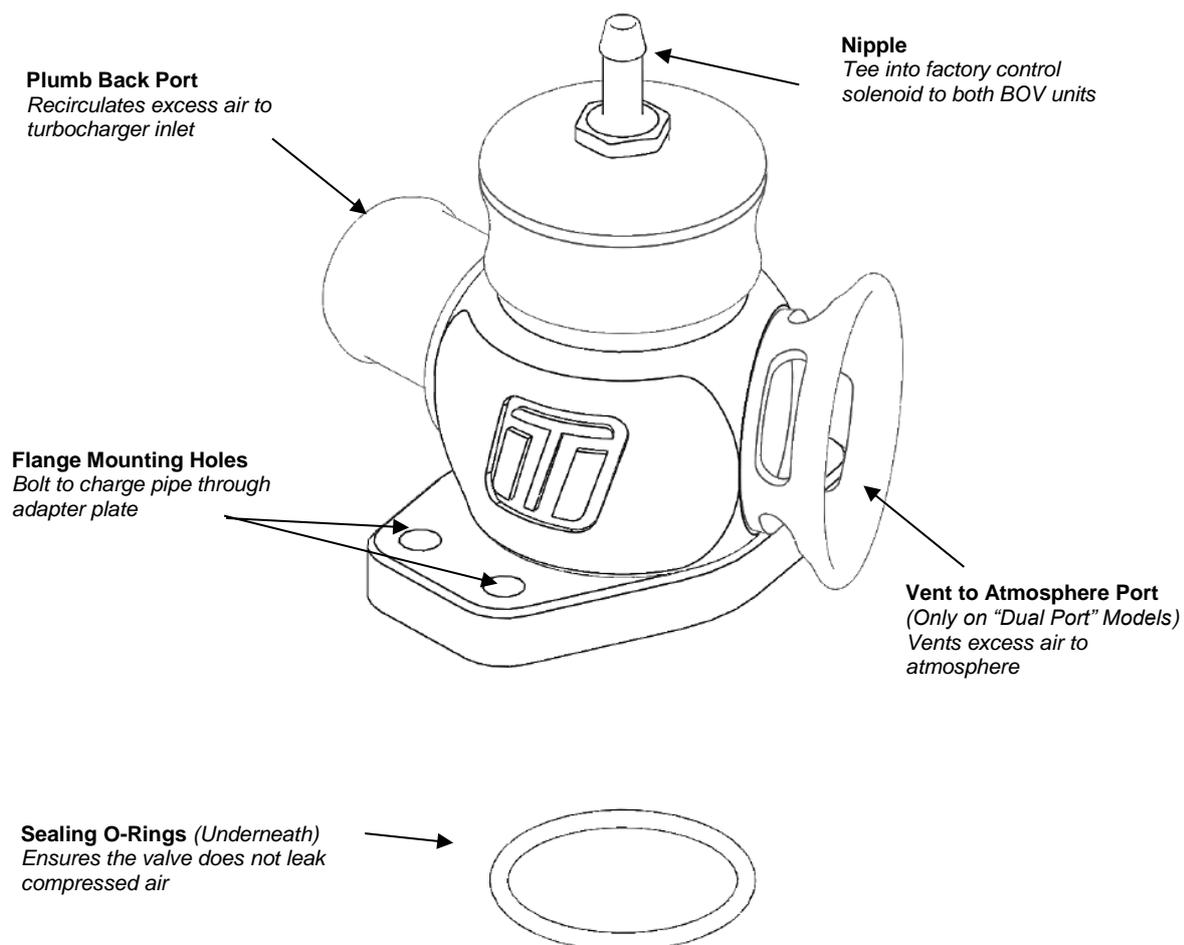
Figure 2 – Stinger Kompact BOV Overview

A direct fit high performance replacement for the factory all plastic unit, the Turbosmart Kompact BOV suits the Kia Stinger. The Turbosmart unit is made of billet aerospace grade aluminium with high temperature seals that allows for minimal leakage and a complete seal across the bypass aperture providing as much performance as possible.

- Direct fit upgrade for the factory BOV on Kia Stinger
- Packaged with a blanking plug to switch the unit into pure vent to atmosphere or plumb-back modes
- All billet CNC construction and attractive anodized finish
- Manufactured, assembled and validated in-house at Turbosmart HQ

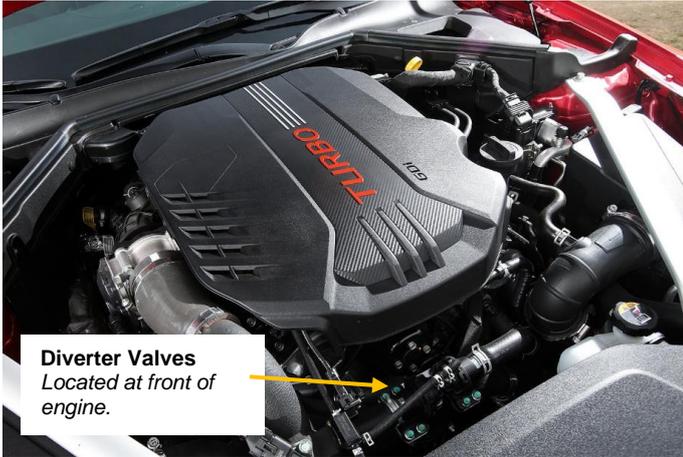
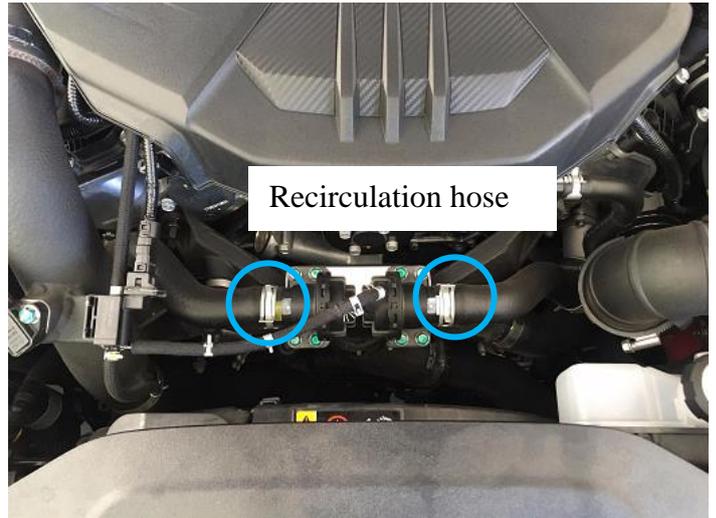
Identify the location of the factory diverter valve assembly, The Kia Stinger factory bypass valves are located at the front of the engine and have easy access

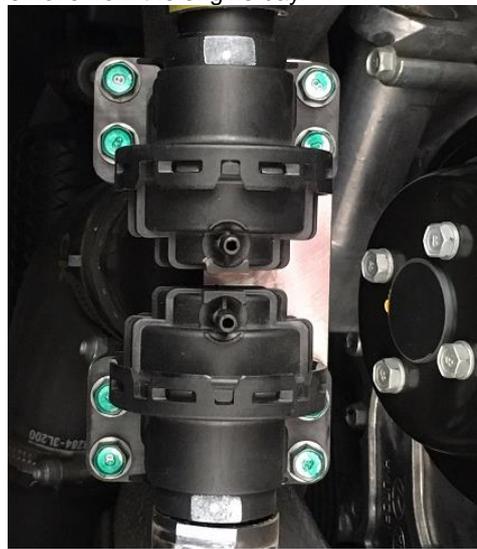
Remove the four bolts holding the diverter valve to the charge pipe and remove from the engine bay.

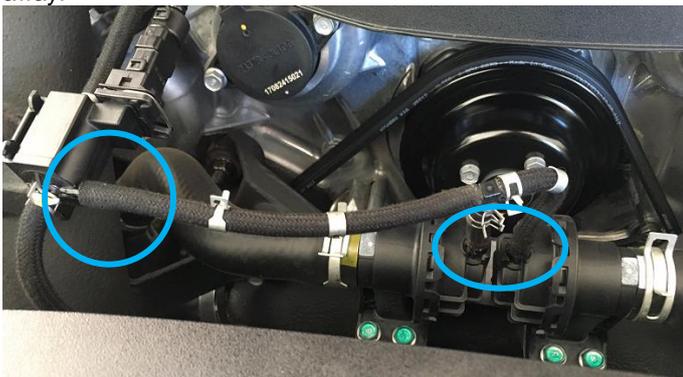
Remove the signal hoses from the factory control solenoid and the bypass valves by clamping the tabs on the spring action hose clamps and moving away from the end of the hose. Twist the hoses to break the initial seal of the hose from the nipple and pull away.

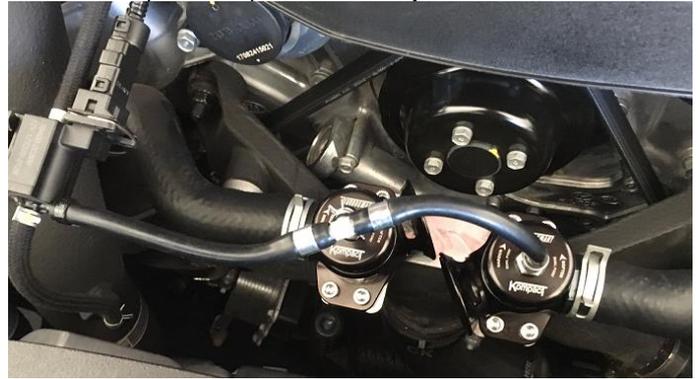
Using the supplied vacuum hose and Tee piece, connect the vacuum hose to the OEM control solenoid using hose clamps to secure it in place. Use the Tee piece to split the hose to join to both BOV's.

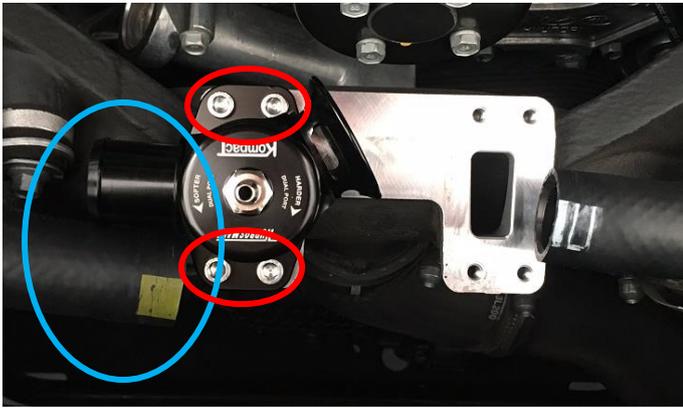
Congratulations, your TurboSMART Kompact Series BOV is installed and ready for use. Double check all connections and mounting screws. Start your engine and check for leaks.

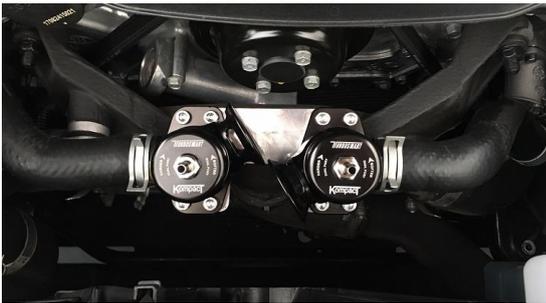
Slide the factory recirculation hoses over the plumb back fitting of the BOV and secure the hose clamps.
